Technical Note N-1267

ANALYSIS OF HYDROPHONE SUPPORT STRUCTURE
AFTER 52-1/2 MONTHS EXPOSURE AT A DEPTH
OF 5270 FEET IN THE BARKING SANDS TEST
RANGE, KAUAI, HAWAII

March 1973

NAVAL CIVIL ENGINEERING LABORATORY
Port Hueneme, California 93043

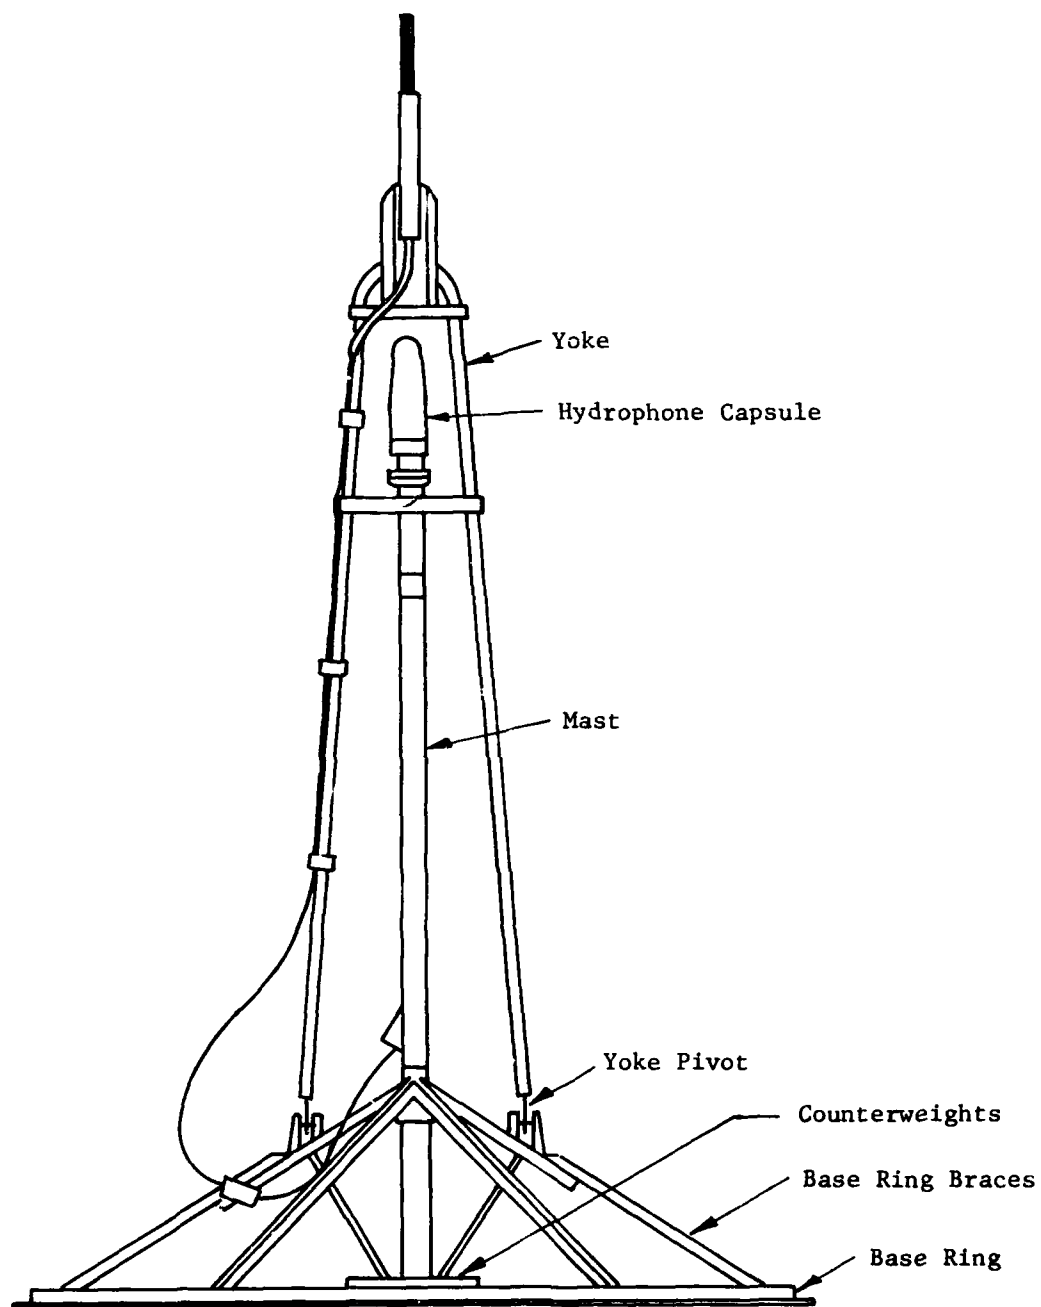
Figure 1. Hydrophone support structure.

The hydrophone support structure, when assembled, is approximately 15 feet high and 12 feet in diameter at its base. A sketch of the structure is shown in Figure 1. The structure was constructed from aluminum alloy bar, plate, channel and extruded tubing, and from PVC, steel, and Ni-Cu alloy 400. Spectrochemical analyses of the aluminum components showed that they were Aluminum Magnesium alloy 5086 which contains nominally 4% Magnesium. Microstructural analysis of polished component sections showed the plate and tube to be in the strain hardened and stabilized condition (H-32) while the channel and bar were in the as extruded condition (H-111). Welds on the aluminum structure were also analyzed and found to conform to the chemical specifications for alloy 5086. Weld deposits of this composition can be obtained by using the filler wire alloy 5356 as specified. Chemical spot tests confirmed that all fasteners were made from Nickel-Copper alloy 400 (67% Ni-33% Cu).
